March 28, 2016

**Re: Lemhi County North Rifle Range Landfill
Draft Compliance Work Plan**

LEMHI COUNTY LANDFILL

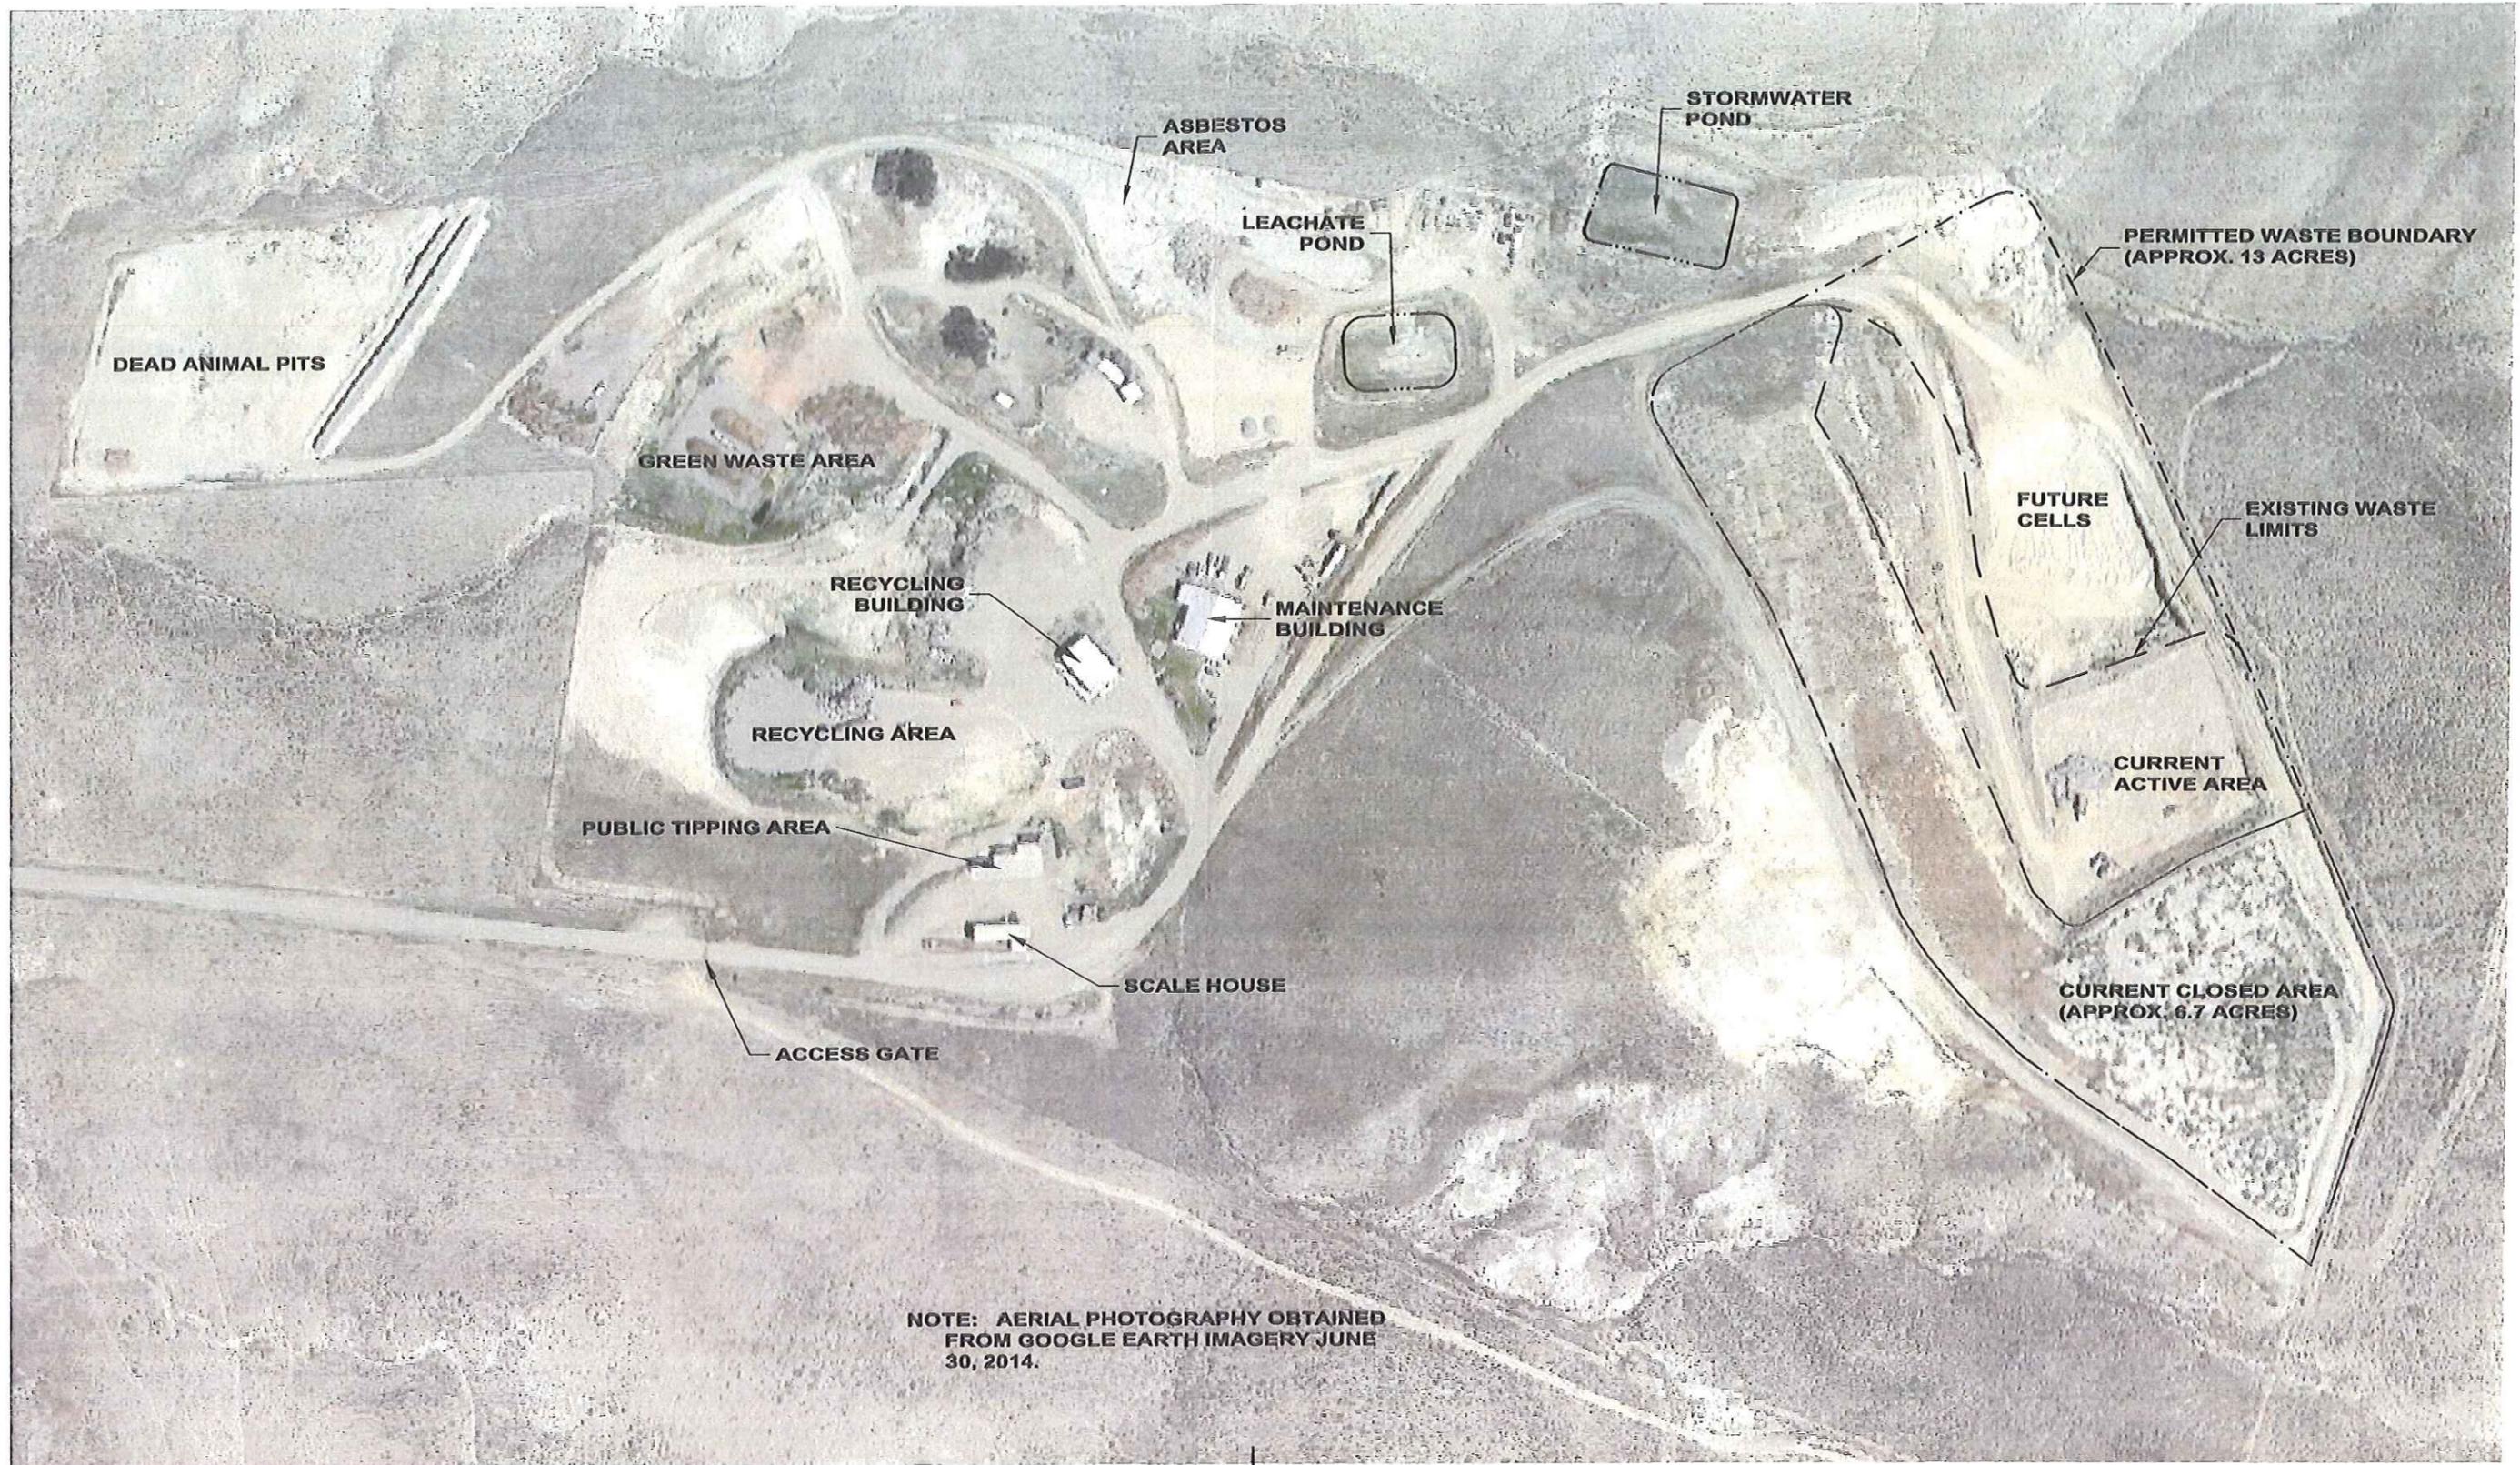
Figure 1
Existing Site Layout

The DEQ has noted that the County has not certified any of the landfill areas closed to date. Based on aerial photography and our site visit, approximately 6.7 acres of the landfill footprint have received final closure to date. Please see attached Figure 1 for

approximate area closed to date. The approved final cover system consists of an 18-inch barrier layer overlain with a 6-inch erosion control layer.

Closure verification will be completed by excavating test pits to verify the lateral extent of the final cover system. Test pits will establish the depth of the final cover and the types of soil materials present. We will notify DEQ of our schedule for the field work so that a DEQ representative can be present if you wish.

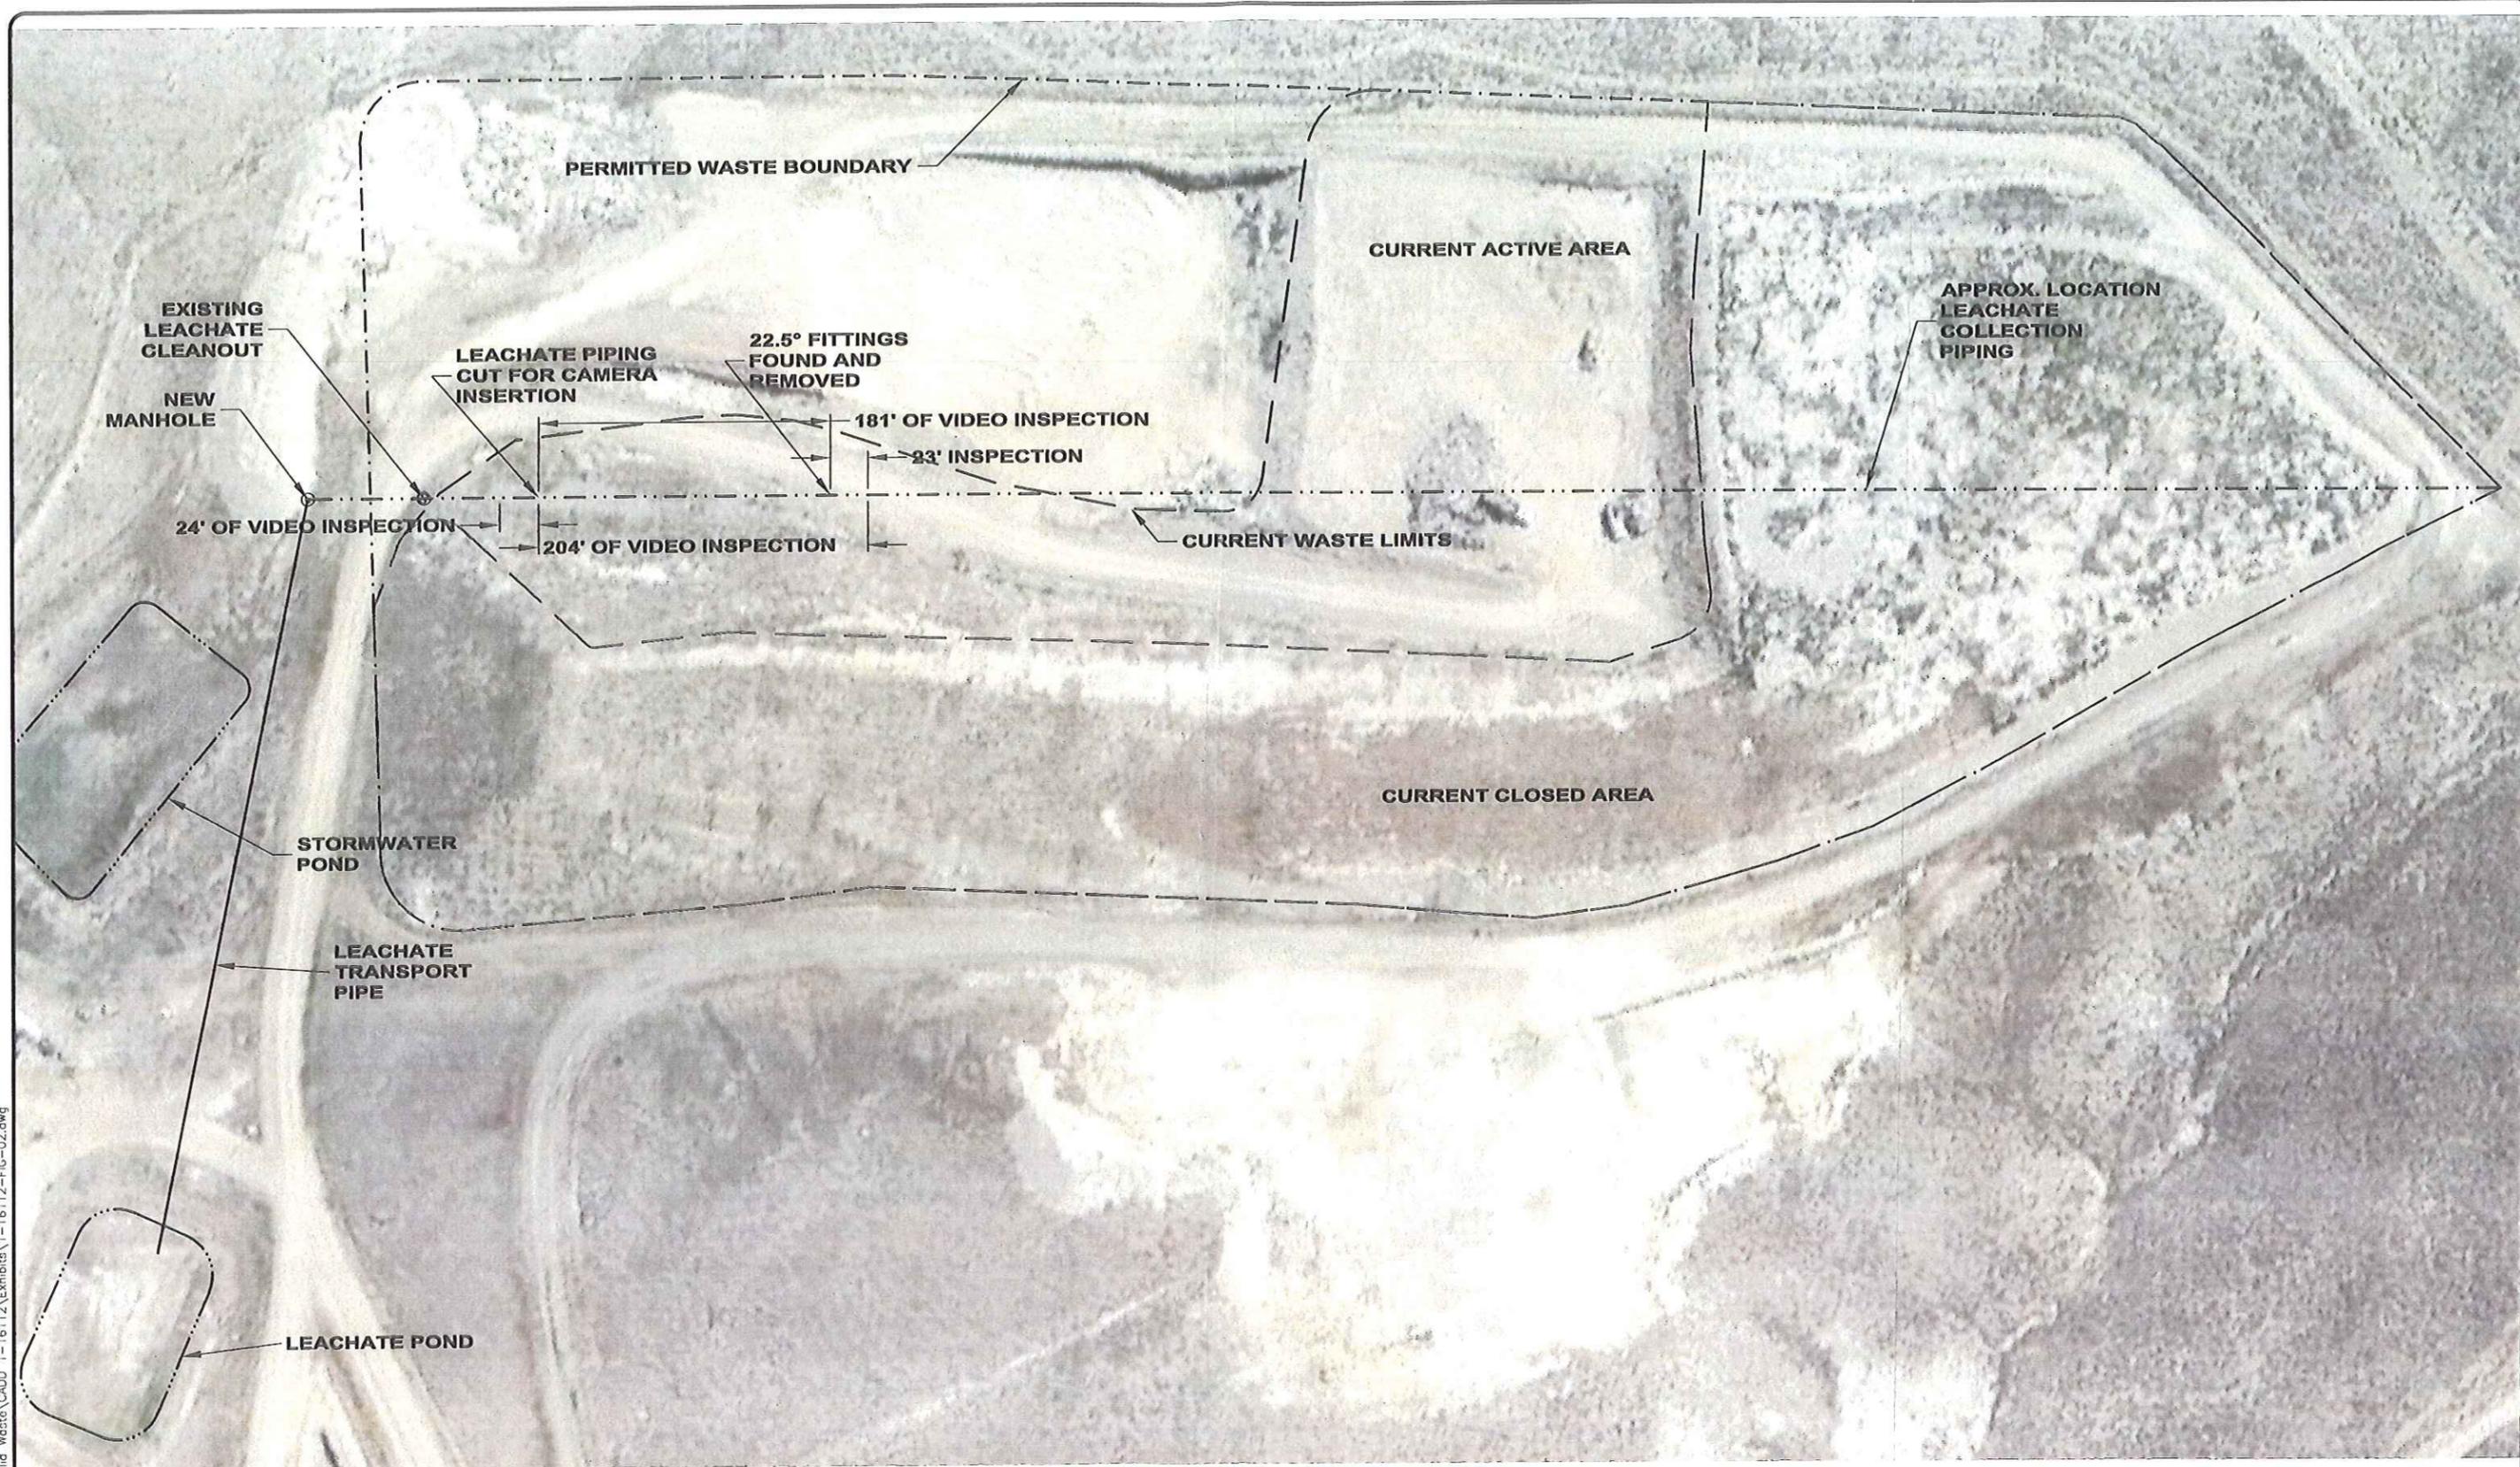
Figure 2
Leachate Collection System

The County exposed the leachate collection system near the lower end of the collection piping on the north end of the landfill footprint (Figure 2). The camera was run up the system to the south for a distance of 181 feet before an obstruction was encountered. The County excavated the leachate collection system at this point and discovered two 22 ½ degree fittings in the leachate system with cast iron couplings. These fittings were removed and the camera was reinserted in the leachate piping and only travelled 23 feet further south before accumulated soil prevented further advancement of the camera. Although only approximately 30% of the cross sectional area was obstructed, the six inch piping has a very small tolerance for clearance of the camera. This completed the inspection effort on this run of piping. The final effort was to insert the camera at the original insertion point and attempt to inspect the run north to the 90 degree elbow in the leachate system. The camera only ran 24 feet before accumulated sediment blocked the advancement of the camera. Again, the cross sectional area of the leachate collection pipe was only 30% obstructed.

Although sediment has accumulated in the leachate piping, we believe the system is still functional with cleaning, further inspection and a few improvements. The video inspection completed to date still shows significant capacity remaining in the piping (70% of design capacity). A significant portion of the leachate collection system is still easily accessible because it has not been buried with waste yet (Please see Figure 2 which shows the current waste limits and leachate collection system). In addition, the portion of the cell which is exposed is the lower end of the leachate system. We

The County proposes cleaning and television inspecting all of the accessible leachate piping in the cell bottom all the way to the leachate collection pond. This will include using a sewer jetter to clean accumulated sediment out of the piping. The County will also clean and inspect as much of the leachate piping as possible that is buried under the waste as possible. The video inspection documentation will be provided for the DEQ's review. We will notify the DEQ of the video inspection work in advance so that a DEQ representative can be present if you wish.

The County proposes several improvements to the system. First, all of the areas which have been excavated to expose the leachate collection system will be repaired with a gravel and fabric collection trench similar to the original design (Figure 16). We also propose the installation of a manhole at the existing 90-degree bend. This will facilitate future cleaning and inspection of the leachate system.
